## Microscopic investigation of subsurface initiated damage of wind turbine gearbox bearings

To cite this article: Jasim H Al-Bedhany and Hui Long 2018 *J. Phys.: Conf. Ser.* **1106** 012029

# Microscopic investigation of subsurface initiated damage of wind turbine gearbox bearings

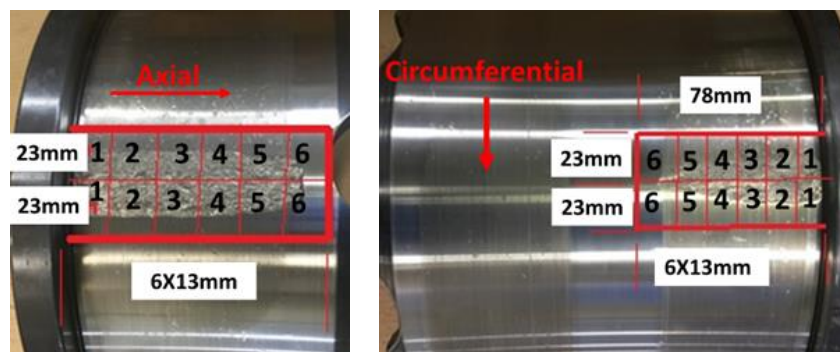
In this study, the severely damaged regions of two planetary bearings are destructively investigated. The samples for microscopic investigation are cut and examined in both axial and circumferential directions of the bearing raceway, as illustrated in figure 1. Samples are mounted using conductive resins to show the investigated surfaces. By using this cutting procedure, the entire axial plane located in the centreline of the severely damaged zone as well as six equally spaced circumferential sections of the raceway can be microscopically investigated. Samples are grinded, polished then etched with 2% Nital (2% Nitric acid and 98% ethanol). Optical microscope and Scanning Electron Microscope (SEM) are used in parallel with EDX technique to investigate the microstructure alterations and different forms of damage. Damage forms such as inclusion-initiated cracks and butterfly wings are characterised according to their damage features defined by dimensions, depth beneath the rolling contact surface, inclination angle relative to the rolling surface and inclusion Aspect Ratio (AR). The subsurface damage initiation is analysed by correlating the damage features with possible loading conditions experienced by the bearings during their operation. Subsurface stress distributions beneath the contact surface and the stress variation due to various loading levels are determined using Hertzian contact theory. Stresses distributions under the effect of surface traction are also calculated to analyse its expected role on damage initiation.

**Figure 1.** Investigated failed bearings and sample locations (upwind and downwind bearing raceways).

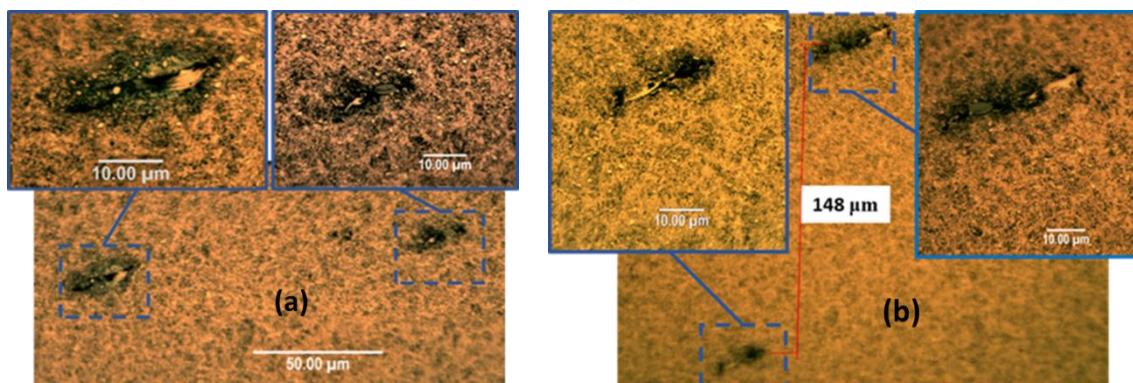
There is no clear correlation between the depths of damaged inclusions with the occurrence of butterflies with upper or lower wing. [figure 6\(a\)](#) shows two inclusions located approximately at the same depth (~320 µm); however, one inclusion has an upper single wing while another has a lower single wing. [figure 6\(b\)](#) shows two inclusions with butterfly wings, the inclusion with an upper wing is located at depth of ~250 µm; however, the inclusion with a lower wing is located deeper at ~148 µm.

**Figure 6.** Depths of butterflies a) two butterflies with upper / lower wing located at the same depth; b) two butterflies with upper / lower wings located at different depths.

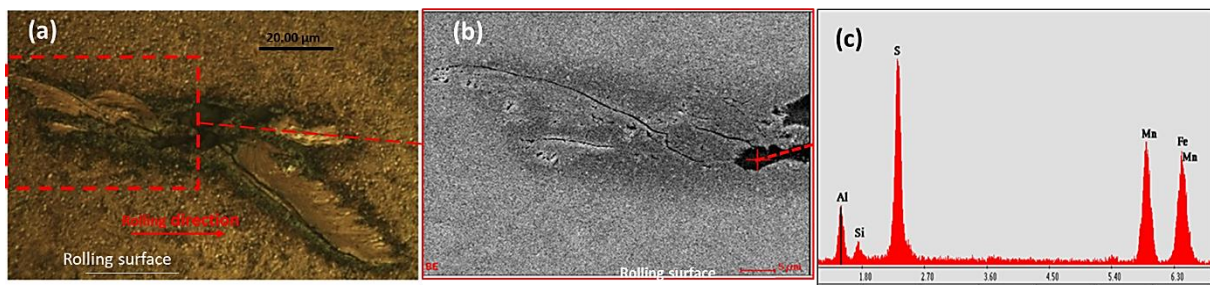
One of the largest butterflies found in this study is shown in figure 7(a). It is located at the end region of the severely spalling area away from rim of the downwind bearing (sample No.6 in figure 1). This butterfly has a depth of ~470 µm beneath the rolling contact surface, within the maximum shear stress zone as shown in figure 2. The inclusion in the centre of the butterfly wings shown in figure 7(b)

has a darker colour compared to that of MnS inclusions which have light grey colour[13]. Energy Dispersive X-ray (EDX) analysis is used to confirm the inclusion's chemical compositions, as shown in figure 7(c). The analysis shows that it is a compound inclusion of MnS, aluminium oxide and silica in addition to other chemical compositions. Thus it is the inclusion type  $D_{Dup}$  according to the International Standard ISO-4967:2013[13]. Aspect Ratio (AR) is defined as the ratio of inclusion lengths along the major to minor axes and it is used to evaluate the inclusion shape. It is found that the majority of the butterflies are initiated at inclusions having low aspect ratio of around 2:1. It is also observed that the butterflies are likely associated with inclusions with internal cracks in a direction approximately parallel to the direction of maximum length of the butterfly wing.

**Figure 7.** Inclusion initiated the largest butterfly: a) optical image; b) SEM image of one wing; c) EDX of central inclusion.

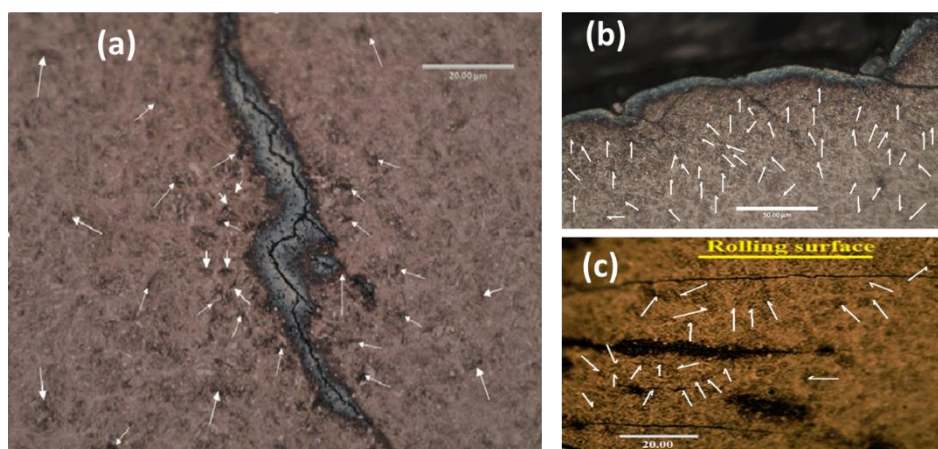
A considerable number of microcracks along a macrocrack are observed on a sample which is over etched as shown in figure 8(a) (marked with white arrows). Further inspections find that considerable microcracks exist on other samples in both axial and circumferential directions as shown in figure 8(b) and 8(c). The considerable number of subsurface microcracks and macrocracks have also been observed in the previous studies [2][22][23][24] however so far limited investigations exist to explain their role on WSF.

Microcracks are found near the sides and ends of the macrocracks where the number of microcracks is much higher than the number of the damaged inclusions. This leads to a postulation that both inclusion and microcracks are the initiators of subsurface microstructural damage leading to WSF. However, the weak boundaries and the residual stress around inclusions play an important role in subsurface damage initiation.

**Figure 8.** Over etched specimens showing microcracks: a) and b) circumferential sectioned samples c) axial sectioned sample.

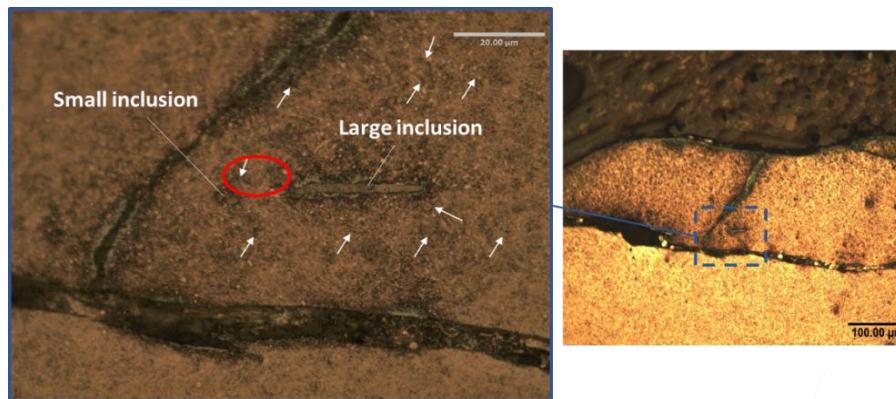
**Figure 9.** Large inclusion unconnected to surface crack network in axial sectioned sample.

The evidence of the role of subsurface microcracks on damage initiation is also shown in an axial sectioned sample in figure 9. A relatively large inclusion located close to the contact surface does not connect to the macrocracks network around it, despite the inclusion is connected to another small inclusion with a crack (marked with a red ring), the two connected inclusions are not connected to the macrocrack network. A considerable number of microcracks around these two inclusions can be seen (marking by white arrows). This leads to a postulation that subsurface microcracks and/or the cracks initiated from the separation of inclusion boundaries probably propagate towards each other, depending on the direction of the maximum shear stress in high stress locations, they then propagate towards the contact surface causing WSF.
