EFFECT OF CONOCARPUS ERECTUS ON THE INFRASTRUCTURE OF MISAN PROVINCE, IRAQ

Preprint · July 2020

Ahmed Falih Shamukh^{1*}, Salah Abdulhasan Ghailan² and Dunia Mohi Mohsen¹

¹Department of Animal Production, Faculty of Agriculture, University of Misan, Misan, Iraq

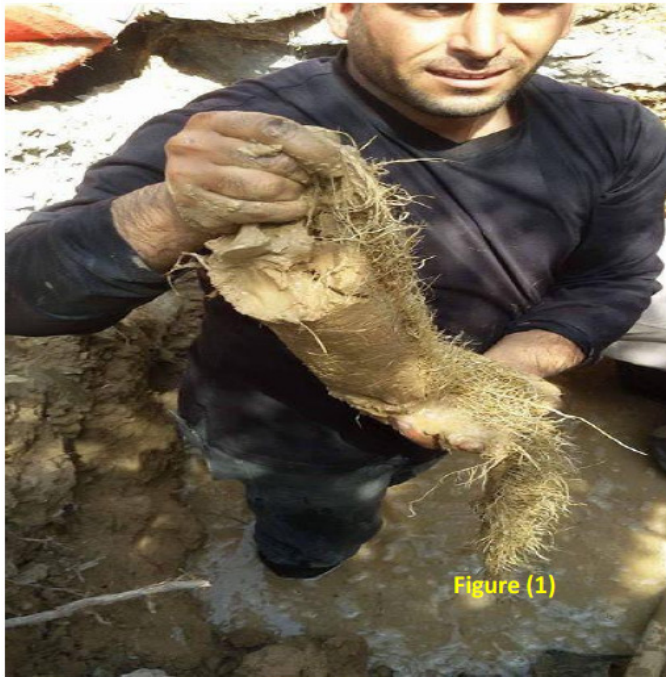
Figure (1)

Fig. 1 : shows The roots are pierced in the water pipe in Al-Ressala Sector

The study showed the main reasons why the roots of the *C. erectus* have been damaged in infrastructure .here, we have to suggest some solutions to get rid of the damage, because the tree bears the environment and gives beautiful green growth. 1- Regular irrigation.so that the root does not extend too deep and cause damage to infrastructure. 2- Pruning leaf to reduce water loss. 3 - plant trees away from the infrastructure, This tree can be used as a windbreaker around the cities, or forest being the tree talking of lack of water and own a powerful root and growth of its vegetative all dense.

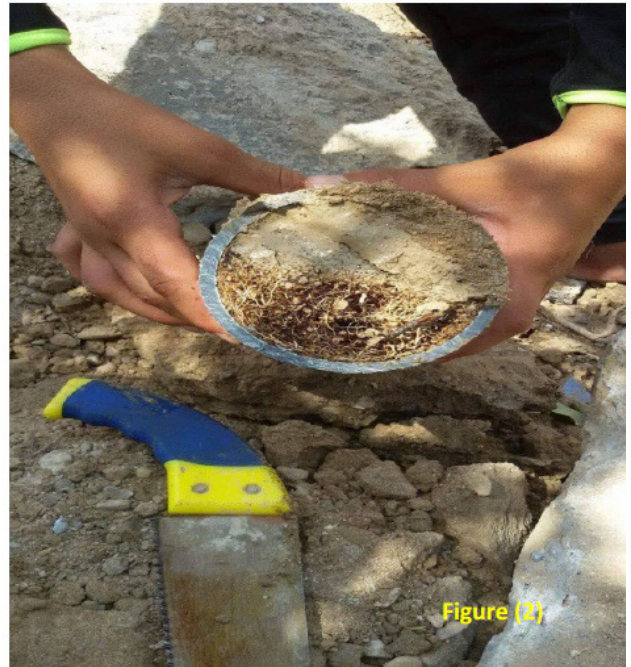
Figure (2)

Fig. 2 : Shows the roots penetrated into the water pipe in Al-Wahda

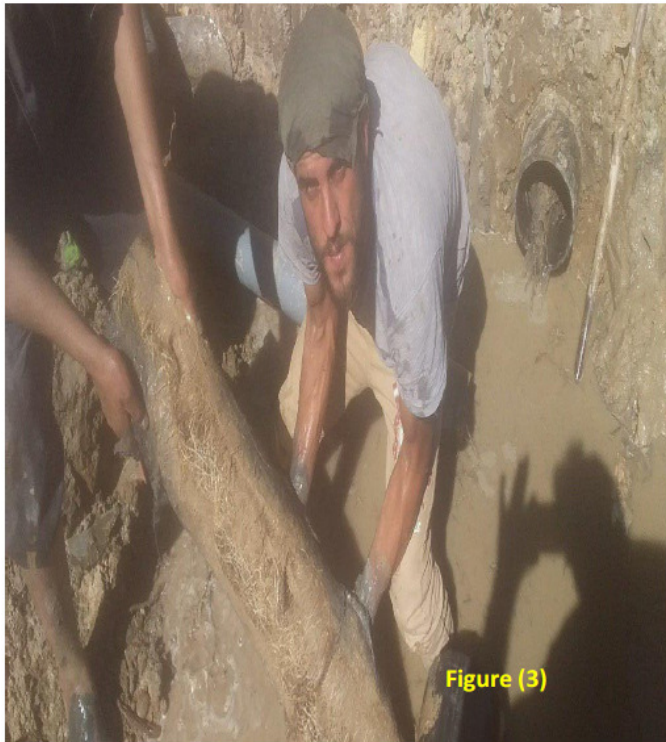
Figure (3)

Fig 3 : Shows the roots were reported to cause a shortage of drinking water after damaging the pipes in residential areas in Al Shobana Sector

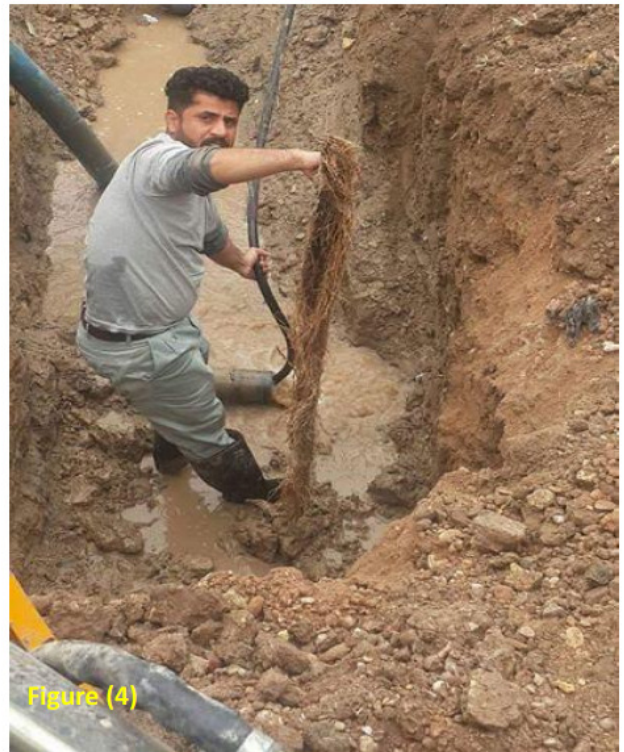
Figure (4)

Fig. 4 : Shows the roots penetration near to domestic Sewage in Al-Sadekh Sector.
