## Microscopic investigation of subsurface initiated damage of wind turbine gearbox bearings

To cite this article: Jasim H Al-Bedhany and Hui Long 2018 *J. Phys.: Conf. Ser.* **1106** 012029

# Microscopic investigation of subsurface initiated damage of wind turbine gearbox bearings

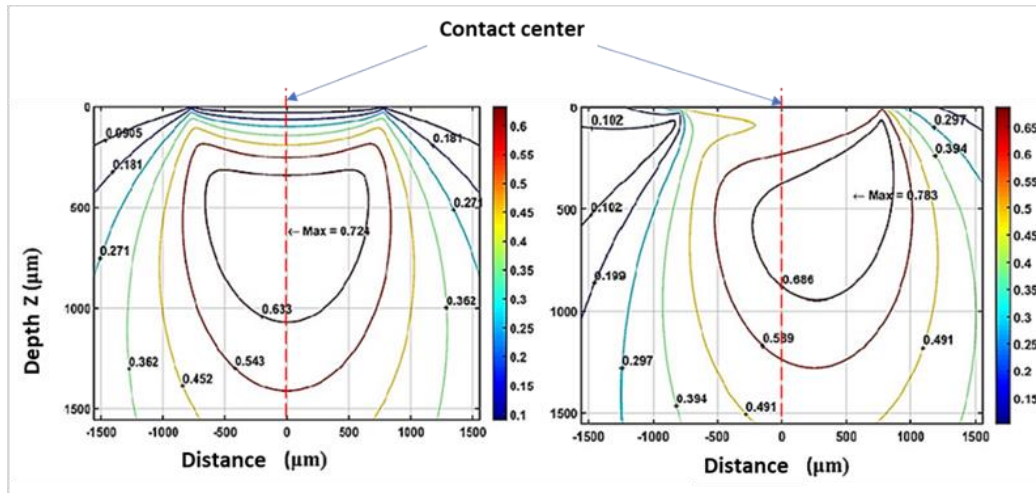
Subsurface stress distributions beneath the contact surface are calculated using Hertzian contact theory by applying compression and traction loading according to the designed stress level specified by the international standards[20][21]. [figure 2](#) shows the distributions of the maximum shear stress when under compression only and under combined compression and traction respectively. Increasing the compressive loading moves the maximum shear stress zone further away from the contact surface. Introducing surface traction into compression moves the maximum shear stress zone closer towards

the contact surface. The maximum shear stress zone will be compared with the locations where various forms of damage are found in the following sections.

**Figure 2.** Distributions of maximum shear stress (in GPa), (left) under compression loading 1.8 GPa and (right) under combined compression loading 1.8 GPa and 0.2% traction.

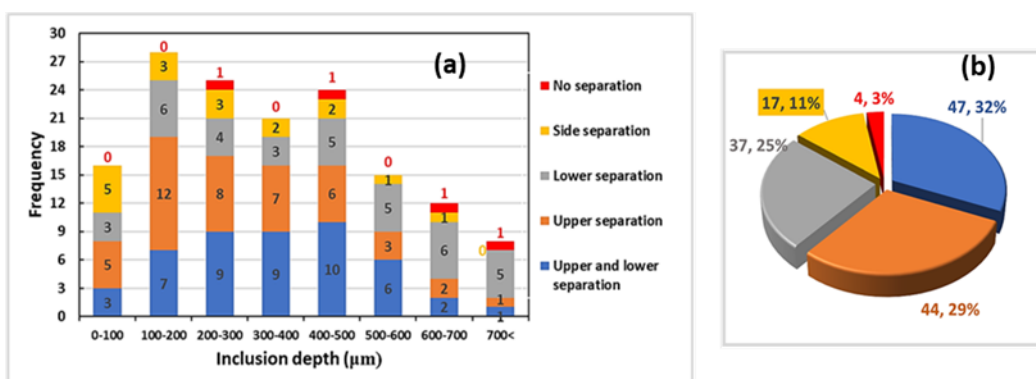
Different forms of inclusion related damage are found in subsurface of the bearing rolling contact, including: inclusions separated from the matrix, cracks extended from inclusion into the matrix and butterfly wings. Percentages of different types of damaged inclusions with their depths are presented in figures 3 and 4. All separated inclusions are found to be located approximately within the depth of the maximum shear stress zone in the subsurface of the contact. For inclusions with separation in the centre of the upper side of the inclusion boundary, the damage may be due to shear stresses with surface traction, since the traction effect brings the maximum shear stress zone closer to the contact surface. The numbers of inclusions with separation at the lower side of the inclusion increase with the depth. By comparing the depths of damaged inclusions by separation in figure 3(a) with the depth of the maximum shear stress shown in figure 2, it is clear their depths are closely correlated.

**Figure 3.** Damaged inclusions by separation: a) in relation to subsurface depth; b) numbers and percentages of separated inclusions.

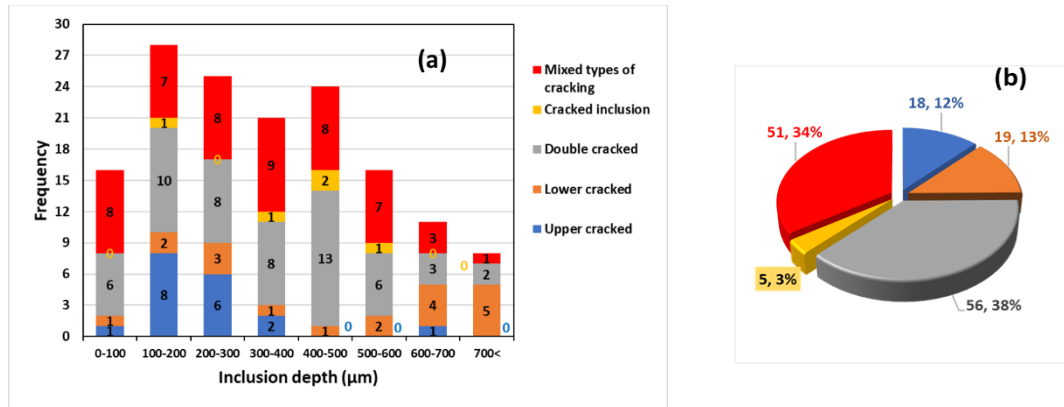
Inclusions with separation are the most dominant damage form however damaged inclusions by cracking are also observed. The cracks appear in different forms: in the tip of the upper side of the inclusion (towards the rolling contact surface), in the tip of the lower side of the inclusion, internal cracking of the inclusion itself, or combined cracking of these different forms. Inclusions associated with cracks are approximately located within the depth of maximum shear stress in the subsurface of

the contact as shown in [figure 4](#). The characterization of damaged inclusions supports the previous suggestion that the inclusion-initiated damage in subsurface may be resulted from effects of shear stresses and the cracking appears along the maximum shear stress plane.

**Figure 4.** Damaged inclusions by cracking: a) in relation to subsurface depth; b) numbers and percentages of cracked inclusions.

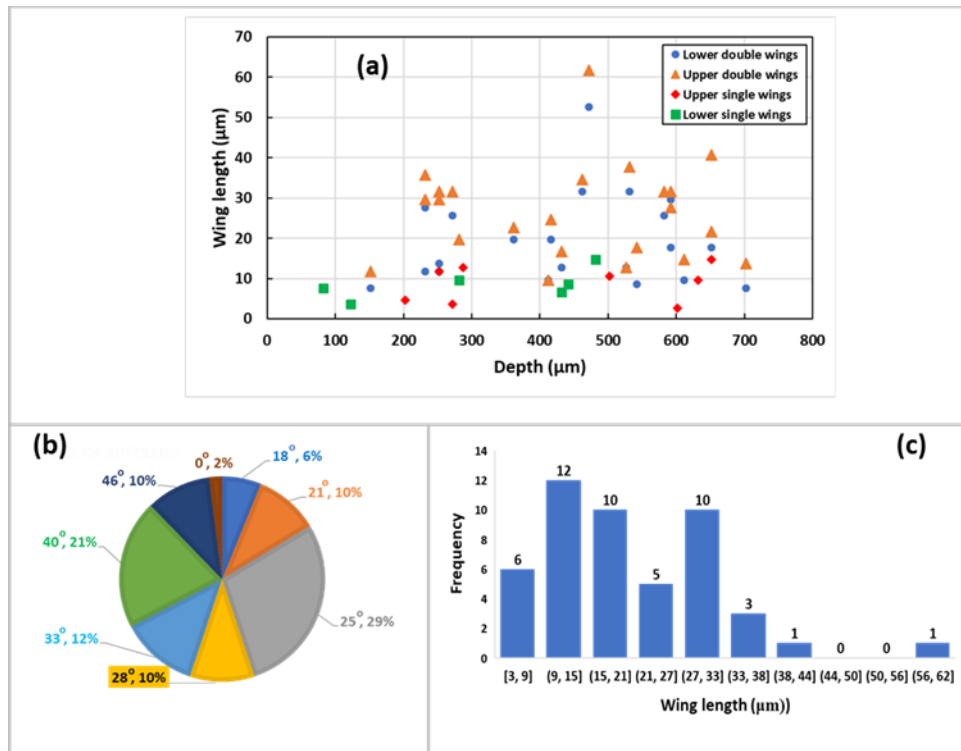
The depth distribution of the 49 observed butterfly wings is shown in [figure 5\(a\)](#). All butterflies are in the circumferential-sectioned samples, approximately located at the depth of the maximum shear stress. Number of butterflies observed increases with increasing depth, however no butterfly is found in depth greater than 700 µm. Only one small butterfly wing is found parallel to the contact surface. Considerable butterfly wings have an inclined angle to the rolling contact surface at 25° or 40° respectively, counted as 29% and 21% of all butterflies, as shown in [figure 5\(b\)](#). [figure 5\(c\)](#) presents the distribution of butterfly wings according to the lengths of their wings. Because the investigated samples are cut from the severely damaged region of the bearing raceways where some parts of the contact surface are removed by severe spalling therefore no butterflies are found in shallow depths of the rolling contact surface.

Around 71% of the butterflies found have double wings while 57% of the remaining butterflies (29% of all butterflies found) have single wing at the upper side of the initiation inclusion and the rest butterflies have single wing at the lower side. Single winged butterflies have shorter lengths when compared with the double winged butterflies. This leads to a hypothesis that butterfly wings may have initiated as a single wing first and the other wing appeared later, then they propagated together to grow into longer wings. There is no evidence to support whether the upper or the lower wing has initiated first however the point of wing initiation may depend on the location of the damage initiating inclusion in relation to the location of maximum shear stress. These observations support the suggestion that the maximum shear stress is an influence factor on the initiation of butterfly microstructure damage [22]. It is observed that cracks associated with butterfly wings are probably not a part of macrocrack network that linked to rolling contact surfaces because they disappear after regrinding the sample surfaces where the butterfly wings are observed. However, the butterfly cracks may not play an important role on subsurface damage propagation. All forms of damage are probably produced due to the shear stress levels have exceeded a critical limit of the bearing material.

**Figure 5.** Butterflies: a) wing lengths in relation to subsurface depth; b) wing angles and percentages c) occurrences in relation to wing length.
